## Version 1.6.7c Firmware Release Notes

2450, 2450-NFP, 2450-RACK, 2450-NFP-RACK

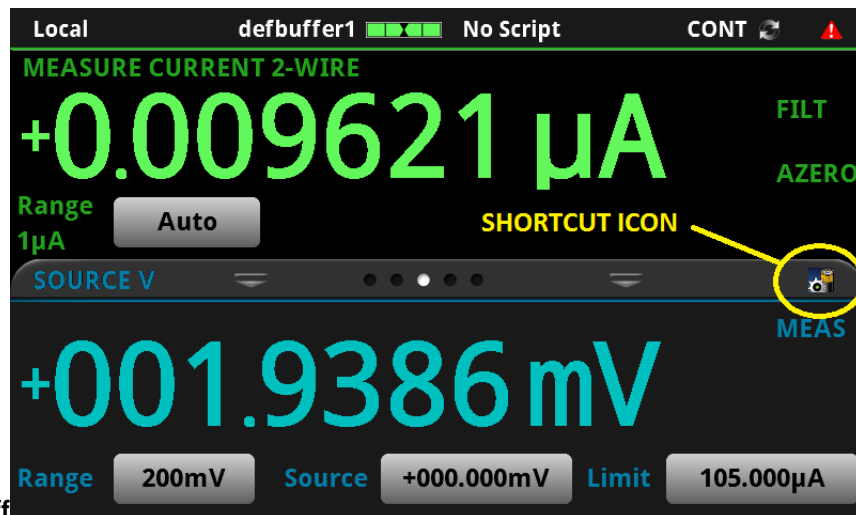
Add a direct shortcut from the HOME view measurement line to the measurement settings menu.

A shortcut icon has been added to the swipe bar on the HOME source/measurement tab.

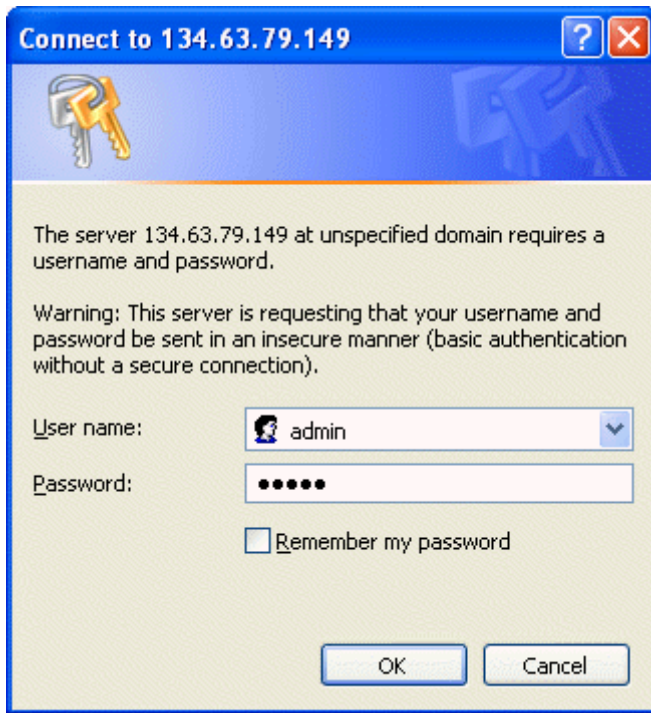
When asked for a Username and Password: enter the Username and Password for that particular 2450. The default Username is `admin` and the default Password is `admin`.
