Model 2450 System SourceMeter®

Version v1.2.0f Firmware Release Notes

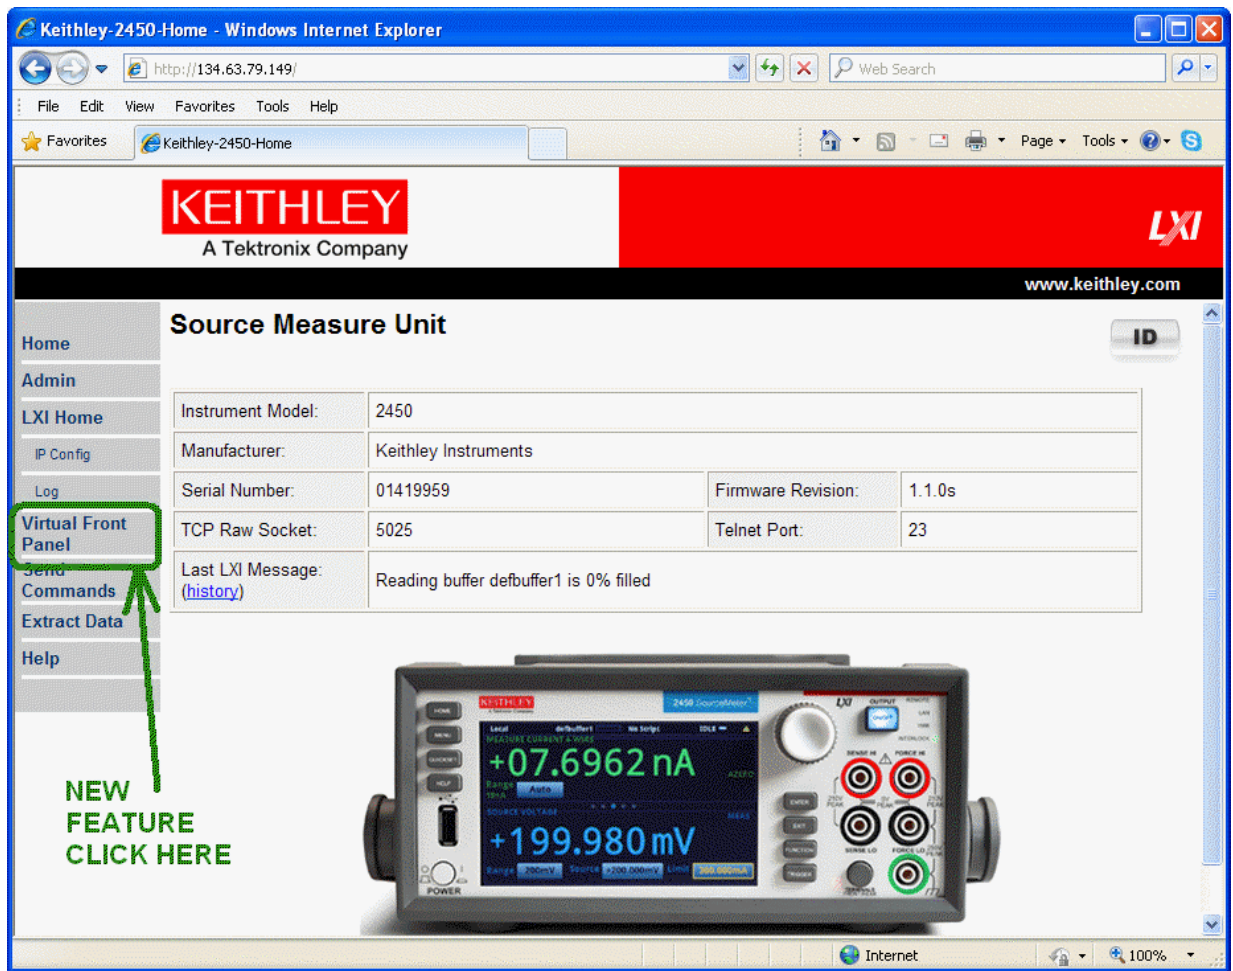
To access the new Virtual Front Panel, access the 2450 through Ethernet using your favorite Internet browser.

Implement new Virtual Front Panel capability.

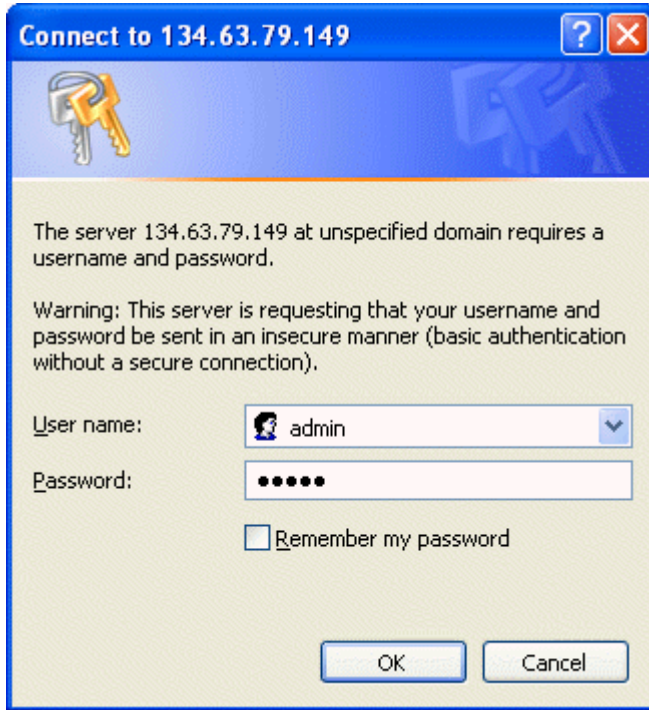
When asked for a Username and Password: enter the Username and Password for that particular 2450. The default Username is `admin` and the default Password is `admin`.

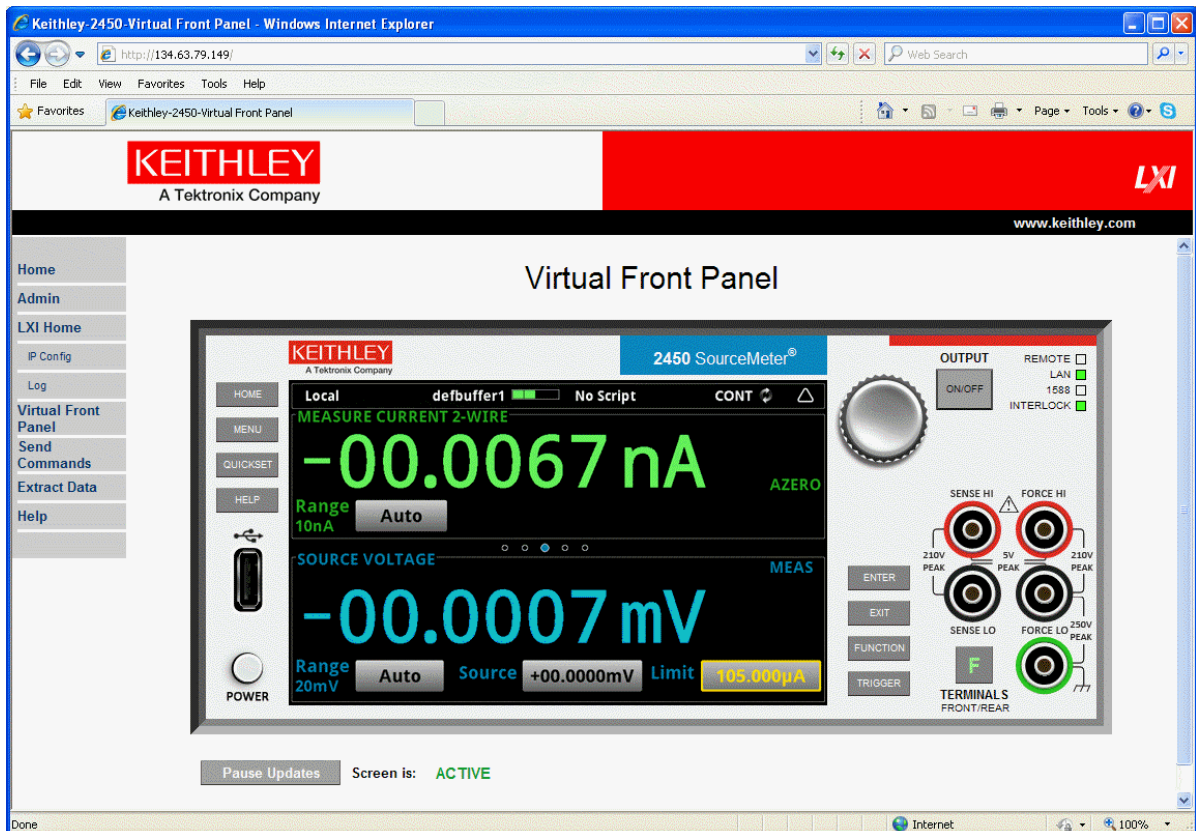
An example of the 2450 Virtual Front Panel is shown below. Users can use their mouse from a standard PC to control the instrument. Users can also use touch screens from most touch screen devices that can access the 2450 IP address.

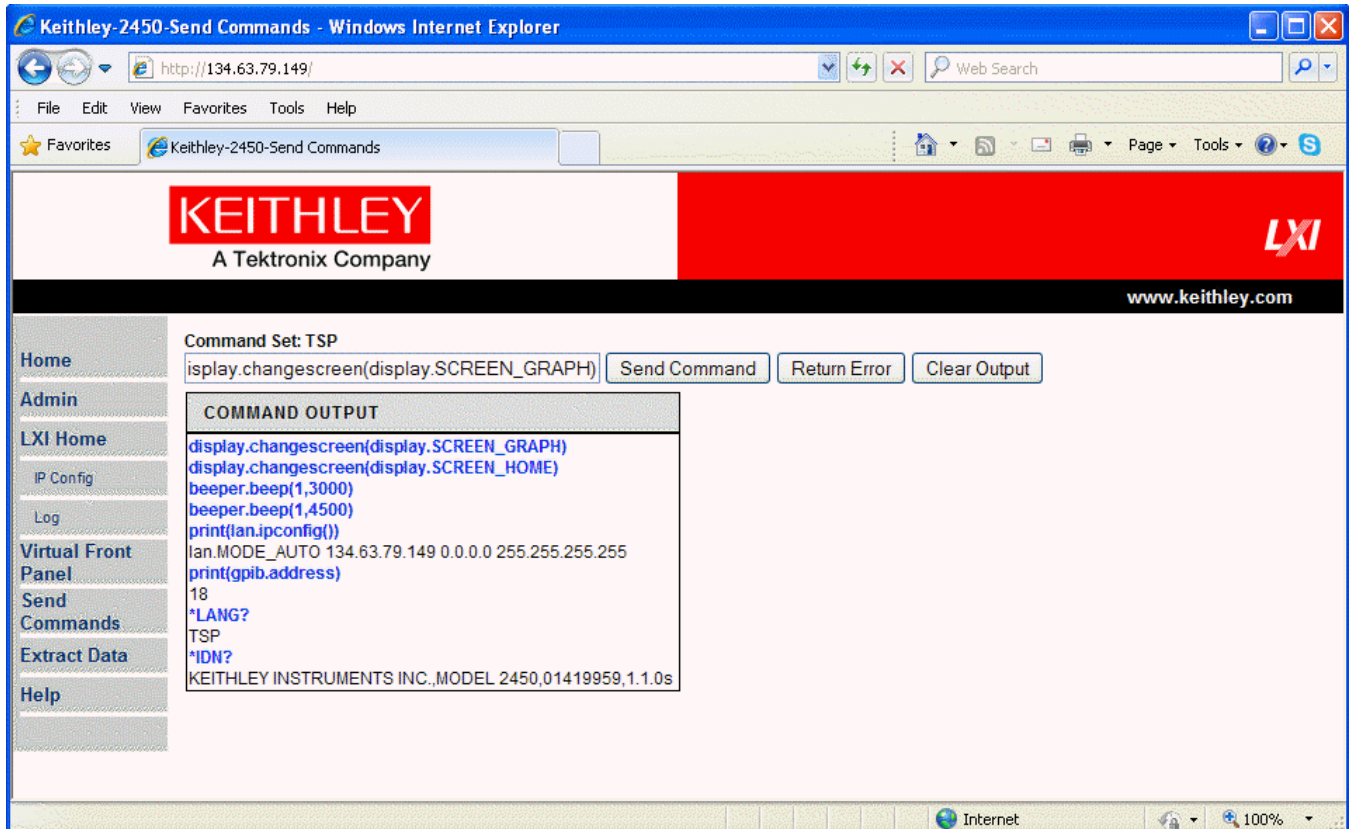
The 2450 built-in webpage has been enhanced to show a historical list of commands recently sent to the instrument. This new COMMAND OUTPUT window has been added to the Send Commands section of the webpage.

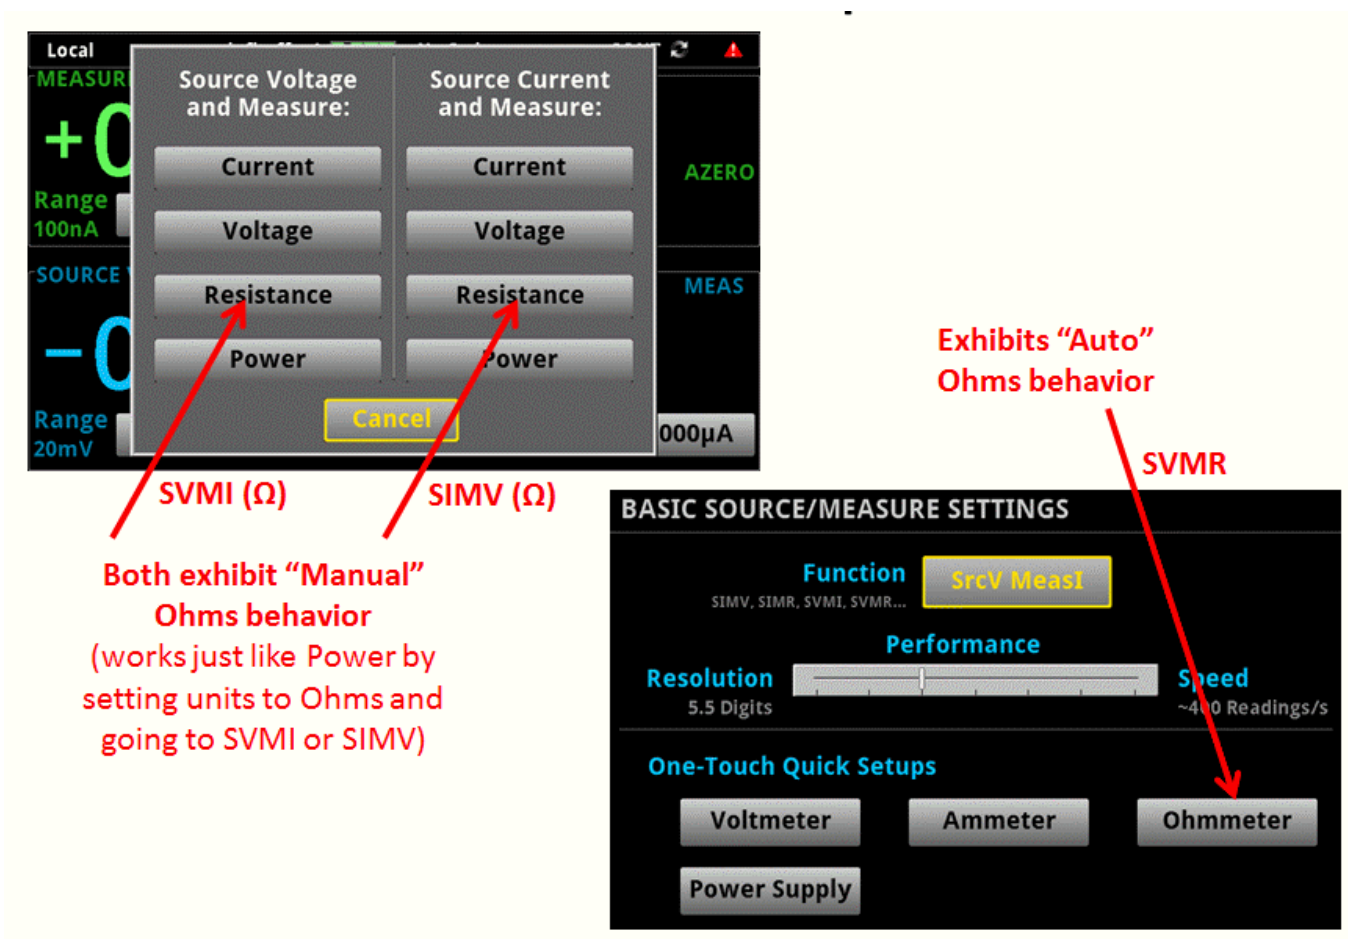
- `smu.measure.func = smu.FUNC_RESISTANCE`
- g. New SCPI Command Usage:
- i. "Manual Ohms" (see definition above)
 - `SOURCE:FUNC VOLTage`
 - `[SENSE[1]]:FUNC "CURRENT"`
 - `[SENSE[1]]:CURRENT:UNIT OHM`OR
 - `SOURCE:FUNC CURRENT`
 - `[SENSE[1]]:FUNC "VOLTage"`
 - `[SENSE[1]]:VOLTage:UNIT OHM`
 - ii. "Auto Ohms" (see definition above)
 - `[SENSE[1]]:FUNC "RESistance"`
- h. Front panel user interface setting of Manual vs. Auto Ohms measurements
- <see the following figure for details>

- `smu.source.func = smu.FUNC_DC_CURRENT`
 - `smu.voltage.func = smu.FUNC_DC_VOLTAGE`
 - `smu.measure.unit = smu.UNIT_OHM`
 - ii. “Auto Ohms” → Measures resistance by sourcing current, measuring voltage, and calculating the resistance reading. In this case, the source current and source limit are automatically calculated and set.
