2460 High-Current Interactive SourceMeter

Version 1.7.16 Firmware Release Notes

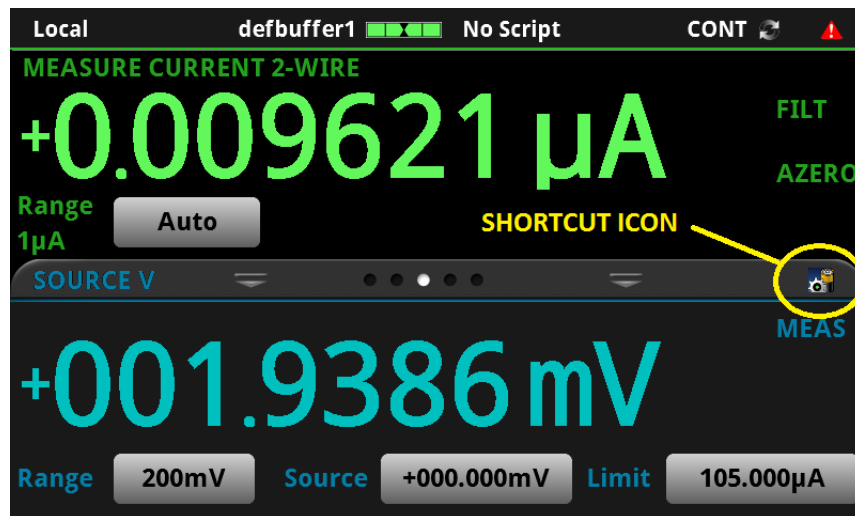
Add a direct shortcut from the HOME view measurement line to the measurement settings menu.

A shortcut icon has been added to the swipe bar on the HOME source/measurement tab.
