Keithley Instruments, Inc.
28775 Aurora Road
Cleveland, Ohio 44139-1891
1-888-KEITHLEY
www.keithley.com

Supported models

2460, 2460-NFP, 2460-RACK, 2460-NFP-RACK

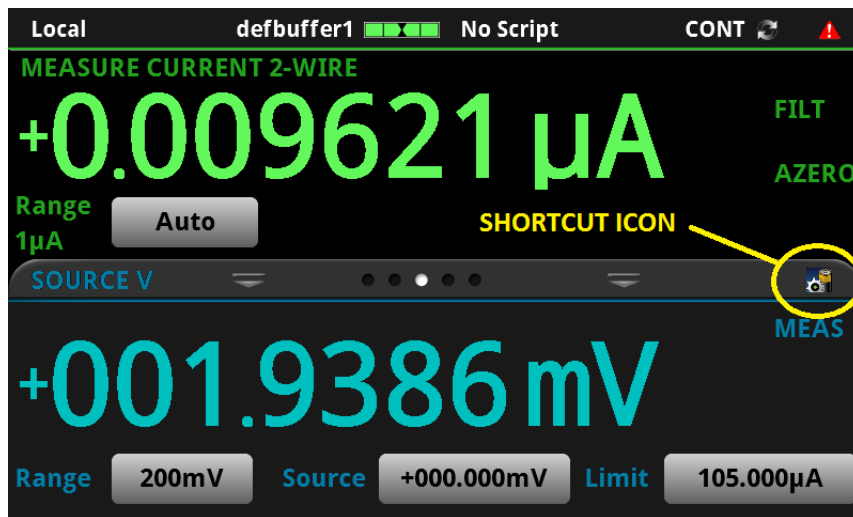
Add a direct shortcut from the HOME view measurement line to the measurement settings menu.

A shortcut icon has been added to the swipe bar on the HOME source/measurement tab.
