Model 2460 System SourceMeter®

Version v1.6.4c Firmware Release Notes

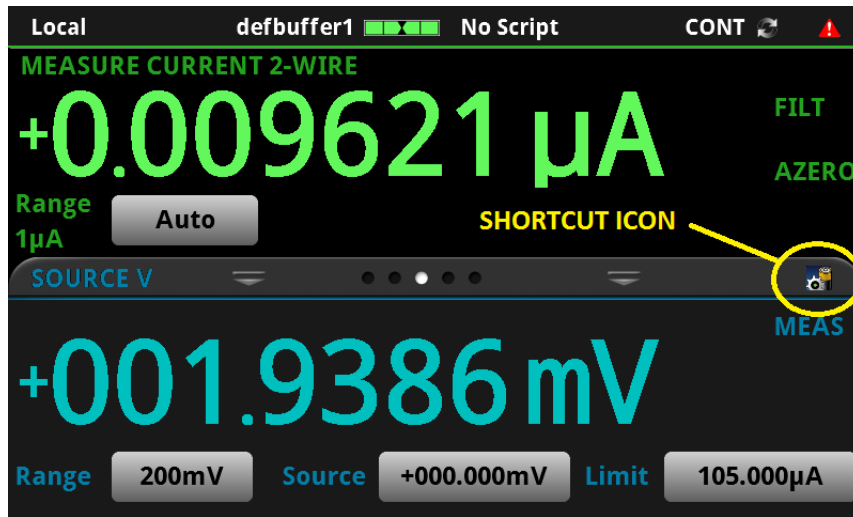
Add a direct shortcut from the HOME view measurement line to the measurement settings menu.

A shortcut icon has been added to the swipe bar on the HOME source/measurement tab.
