Version 1.6.7c Firmware Release Notes

2460, 2460-NFP, 2460-RACK, 2460-NFP-RACK

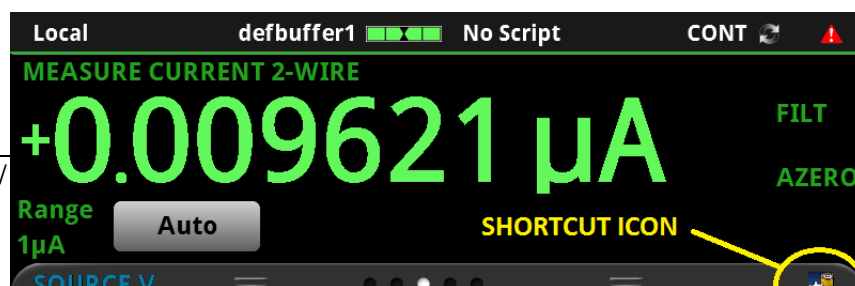
Add a direct shortcut from the HOME view measurement line to the measurement settings menu.

A shortcut icon has been added to the swipe bar on the HOME source/measurement tab.
