**Keithley Instruments**  
28775 Aurora Road  
Cleveland, Ohio 44139  
1-800-935-5595  
[www.tek.com/keithley](http://www.tek.com/keithley)

This firmware, 2260B-FRP-V1.82, is used on the following Keithley Instruments product models:

## Firmware upgrade instructions

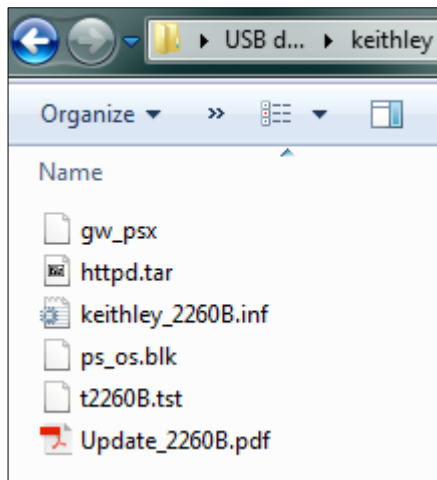
1. Unzip the firmware image archive to the root directory of a USB flash drive. The archive is a \*.zip file; usually with the firmware version in the name.
2. Verify the folder structure:
  - A folder named `keithley` should now exist in the root directory of the USB and its contents should be as shown below:

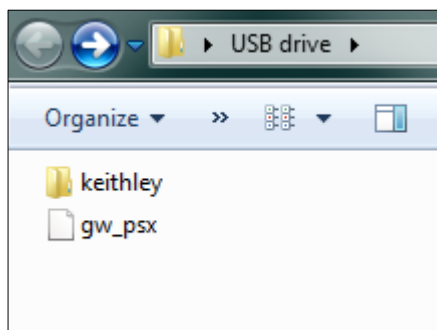
- The `gw_psx` file in the `keithley` directory should be **copied** up to the root directory as shown below:
